Manhole Inspection Summary

Manhole # S09CC1003MH

Insp Date: **6/25/07 2:24 PM**

Location Address: **3818 GRANTLEY AVE**

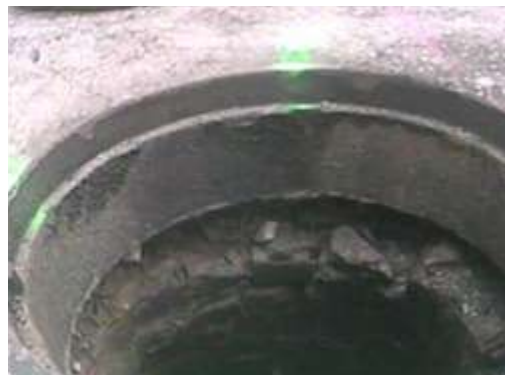
Defect 1

Condition: ☐ Sound ☐ Cracked ☐ Root Intrusion ☒ **Loose Brick** ☒ **Deteriorated**

LOOSE BRICKS AND DETERIORATING
FRAME ADJUSTMENT

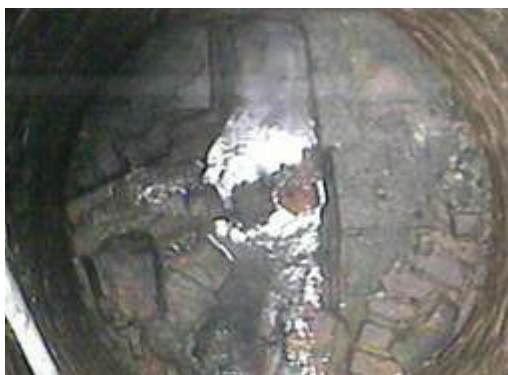
Defect 2

Condition: ☐ Sound ☐ Cracked ☐ Root Intrusion ☒ **Deteriorated** ☐ Leaks ☒ **Debris**

DETERIORATED BENCH AND DEBRIS

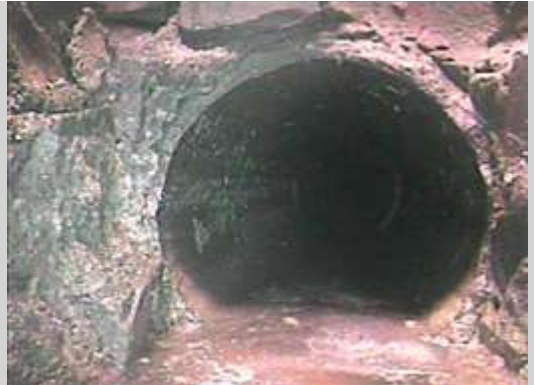
12 O'Clock Outflow

8 in. Circular Gravity Sewer
Pipe Out @ 12 O'Clock

Pipe Height: (in.) Direct
Pipe Material: **Clay** ☐ Pipe Lined
Invert Depth: **6.47** (ft.) Flow Characteristics: **Slow**
Deposits: ☐ None ☐ Mud ☐ Sludge ☒ **Debris** ☐ Grease
Silt Depth: **2** (in.) Deposits Extent: **Light**
Infiltration: **None** Pipe Seal Cond: **Broken**

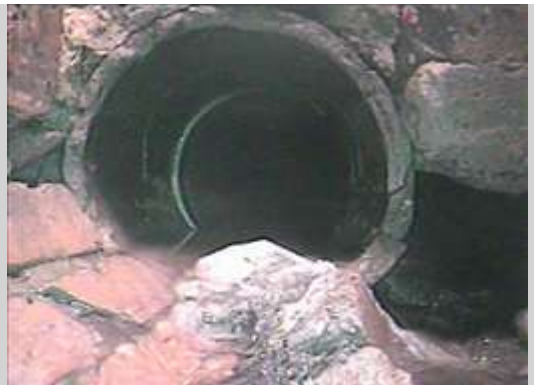
6 O'Clock Inflow

8 in. Circular Gravity Sewer
Pipe In @ 6 O'Clock

Pipe Height: (in.) Direct
Pipe Material: **Clay** ☐ Pipe Lined
Invert Depth: **6.31** (ft.) Flow Characteristics: **Slow**
Deposits: ☒ **None** ☐ Mud ☐ Sludge ☐ Debris ☐ Grease
Silt Depth: (in.) Deposits Extent:
Infiltration: **None** Pipe Seal Cond: **Broken**

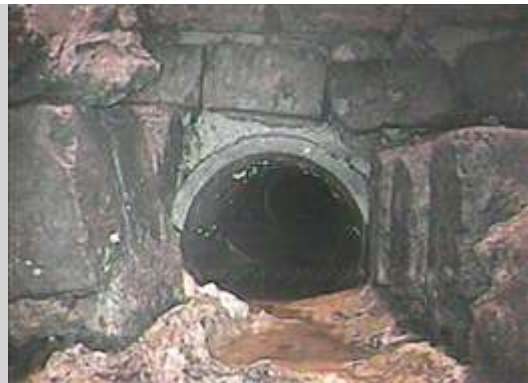
9 O'Clock Inflow

6 in. Circular Gravity Sewer
Pipe In @ 9 O'Clock

Pipe Seal Cond: **Cracked**
